Roof Condition Report

9CFCS- Sewage Treatment

Intermountain Power Service Corporation
850 West Brush Wellman Road
Delta, Utah

June 2001

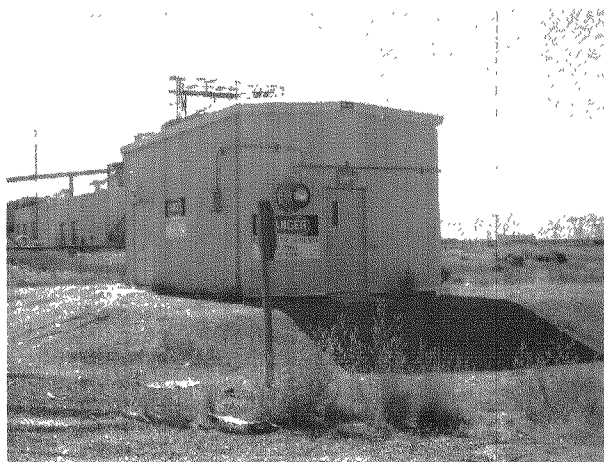
Photo No. 1

From visual inspection, the metal roof is in very good condition. The roofing panels were tight and not fasteners were loose.

The metal finish is in very good condition, with no sign of rusting or corrosion.

From visual inspection, the roof is in very good condition. The screws were all tight, as were the metal roof panels. Very little degradation of the roof materials was visible.
